Crude Distillation Unit Heater Lining Replacement with Pyro-Bloc[®] Modules

Industry: Petrochemical
Application: Crude Distillation Unit Heater
Product Solutions: Pyro-Bloc Modules
Location: South Korea

June 2021

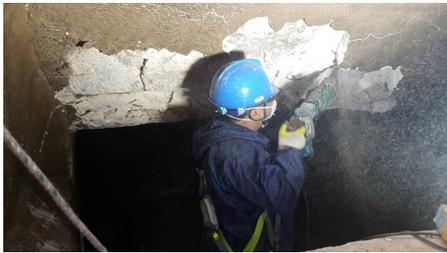
Figure 3:
Demolishing original castable lining

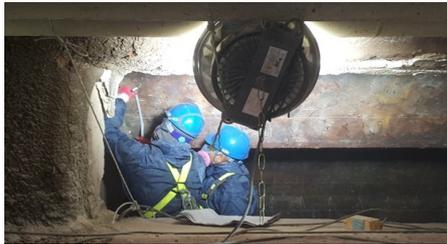
Figure 4:
Measuring the distance for stud layout

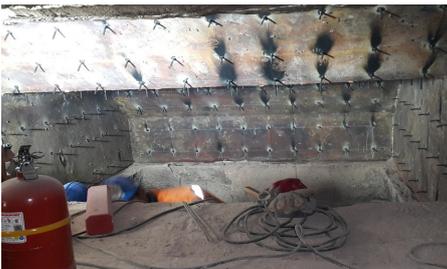
Figure 5:
Welding studs for Pyro-Bloc Modules after marking with chalk lines

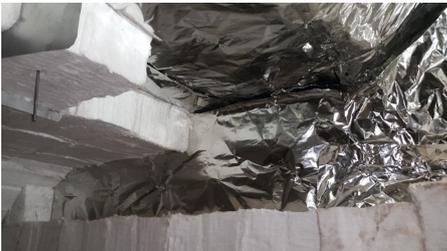
Figure 6:
Stainless steel foil vapour barrier being installed

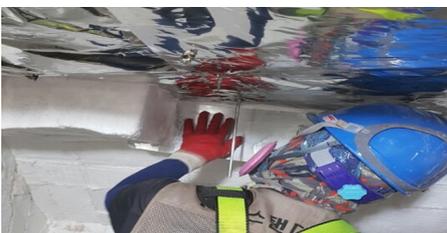
Figure 7:
Installation of Pyro-Bloc Modules

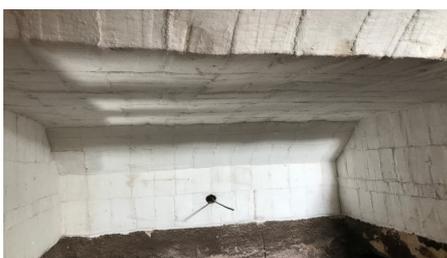
Figure 8:
Completed installation
